Manhole Inspection Summary

Manhole # S21CC1008MH

Inspection ☐ Is Incomplete Rating: **4) Poor**

Location Address: **UNION AVE**

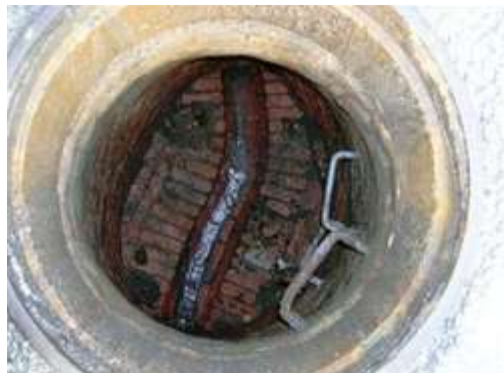
Top View

Corroded steps. Evidence of surcharge - Bench debris.

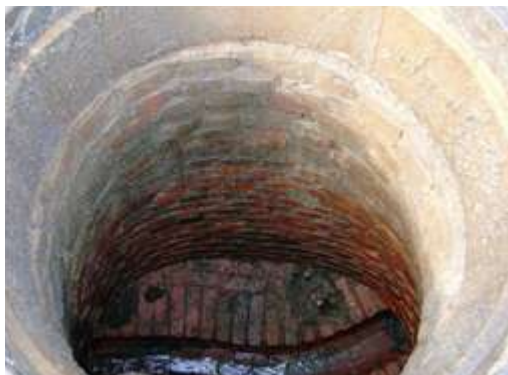
Defect

Frame leaks. Adjustment deterioration and infiltration. Corbel infiltration.

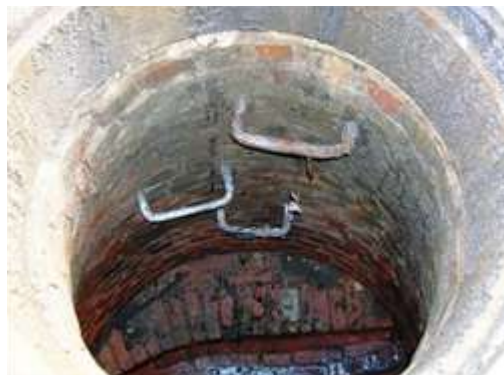
Defect

Frame leaks. Adjustment and Corbel infiltration - other side.

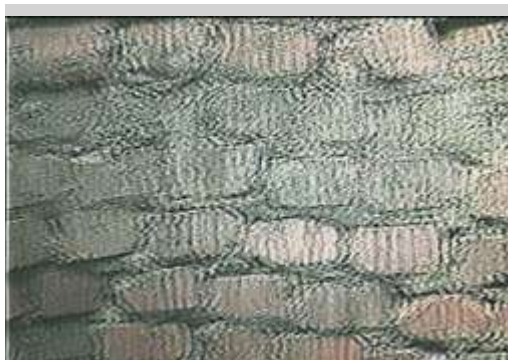
Defect

Barrel deterioration and infiltration.

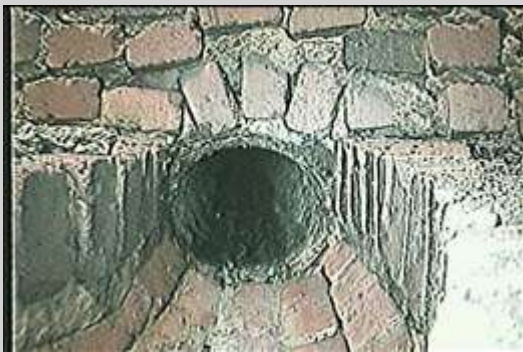
8 in. Circular Gravity Sewer Pipe Out @ 12 O'Clock

Barrel deterioration and infiltration. Bench and Channel deterioration.

Deposits: ☐ None ☐ Mud ☐ Sludge ☐ Debris ☒ **Grease**

Infiltration: **Evidence** Pipe Seal Cond: **Unknown**

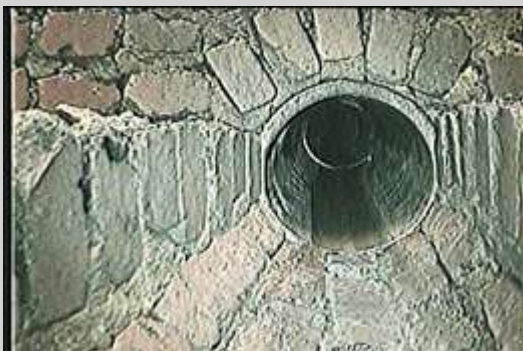
8 in. Circular Gravity Sewer Pipe In @ 7 O'Clock

Barrel deterioration and infiltration. Bench and Channel deterioration.

Deposits: ☐ None ☐ Mud ☐ Sludge ☐ Debris ☒ **Grease**

Infiltration: **Evidence** Pipe Seal Cond: **Unknown**
